CHIEF
JANUARY 1964

OV-1

ACCIDENT SUMMARY

NOVEMBER 1, 1961 TO OCTOBER 31, 1963

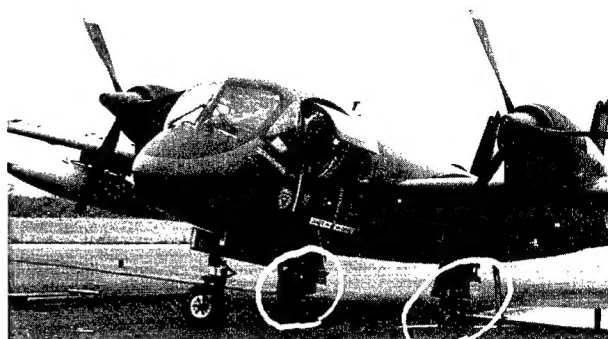
02791

THE ACCIDENT: Aircraft landed with high sink rate in nose-high attitude.

THE CAUSE: Student pilot performed power-off approach with low airspeed. IP failed to take corrective action in time.

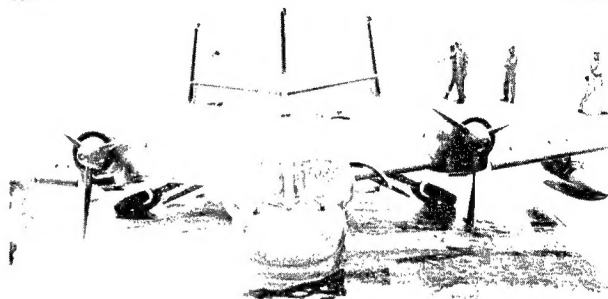
03477

THE ACCIDENT: Landing gear retracted prematurely during takeoff roll. Aircraft settled on runway and skidded 1775 feet before stopping.

THE CAUSE: Suspect pilot inadvertently retracted landing gear by accidentally moving gear handle forward one-half inch during takeoff power application.

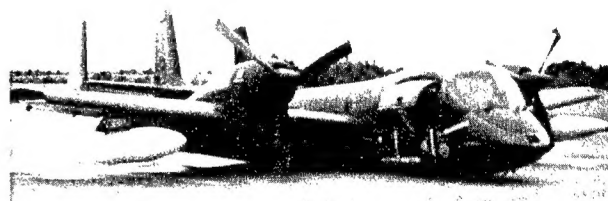
03844

THE CAUSE: IP accidentally moved gear handle instead of flaps lever during roll of touch and go landing.

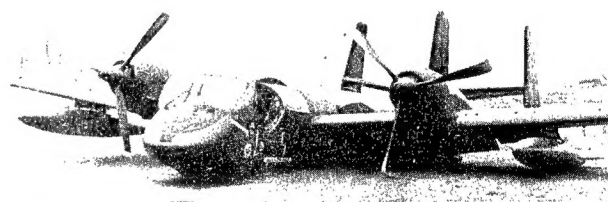
04106

THE CAUSE: High, fast downwind approach and use of reverse thrust before touchdown.

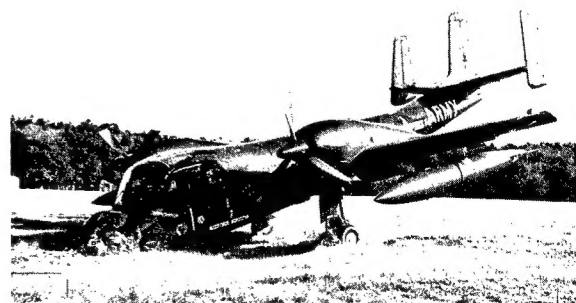
04200

THE ACCIDENT: Nose gear collapsed during landing roll on sod strip. Pilot applied full reverse thrust at touchdown and nose gear drag brace failed, allowing wheel to retract.

THE CAUSE: Materiel failure.

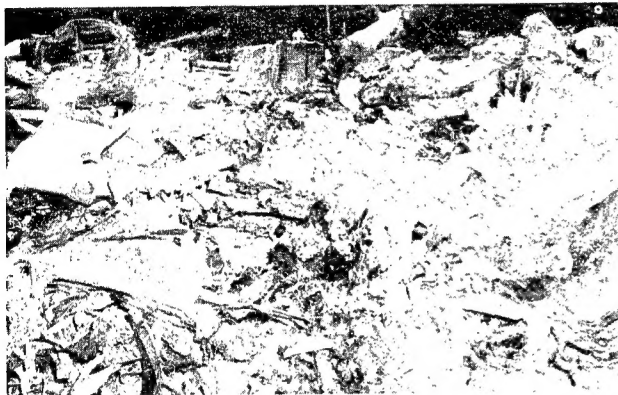
06672

THE ACCIDENT: Explosion occurred next to

fuselage in vicinity of flare pod when remaining flares were salvoed in completion of night photo mission. Fuselage broke in two and aircraft crashed. Pilot ejected and sustained minor injuries. Copilot failed to eject and sustained fatal injuries.

THE CAUSE: The most probable cause of this accident was premature firing of one or more flares which caused an explosion in the flare pod.

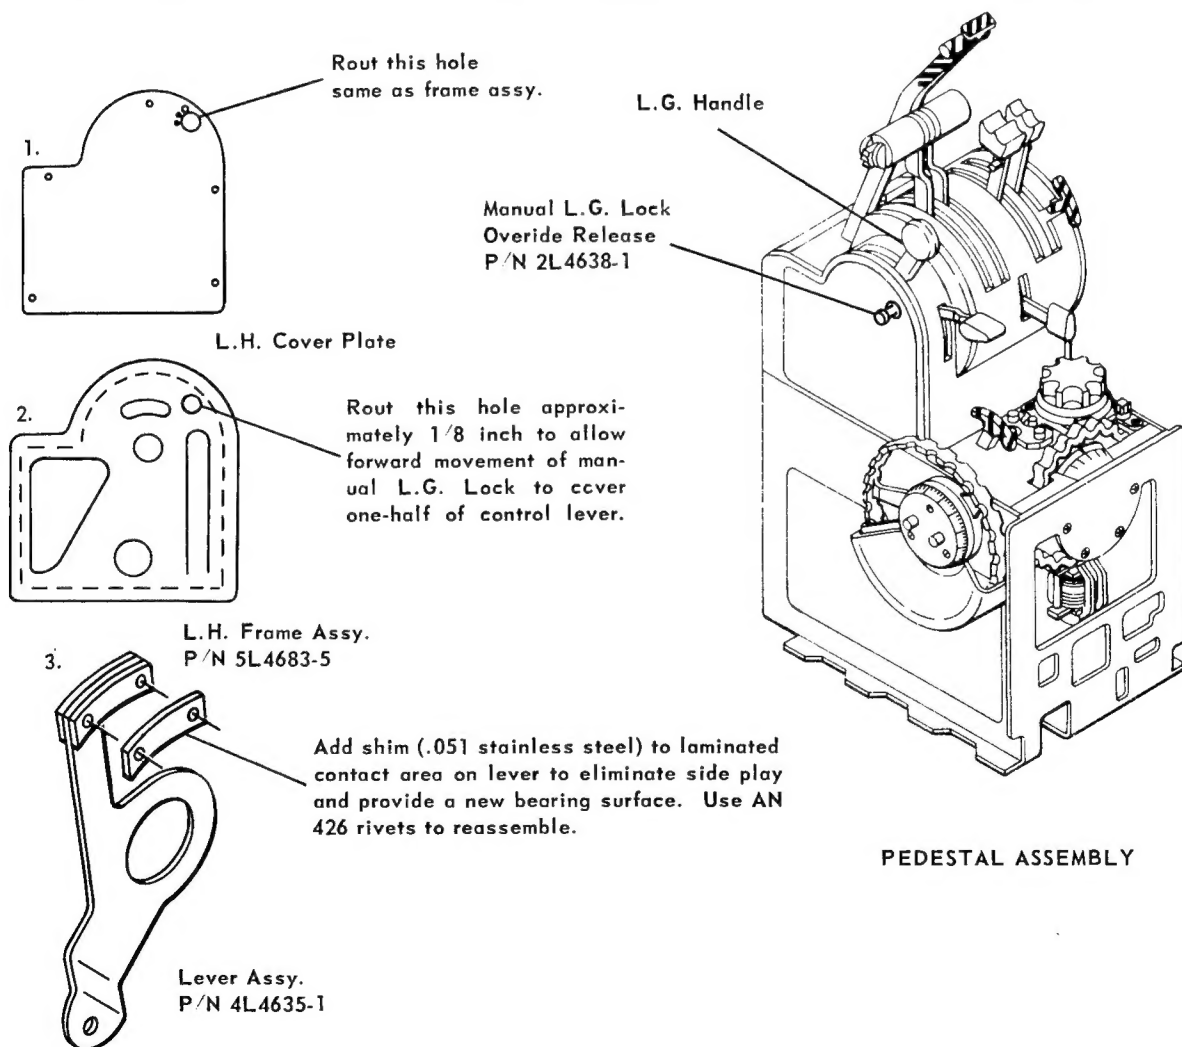
Due to several inadvertent landing gear retractions, MWO 55-1510-204-34 1, 21 Nov 1961, was issued covering inspection of the landing gear lever. Inadvertent retractions can be caused by wear in various parts of the pedestal assembly. Repair as shown should be incorporated during the next scheduled periodic inspection.

TO PREVENT INADVERTENT RETRACTION OF LANDING GEAR DUE TO WEAR AND TOLERANCE BUILD UP OF POSITION LOCK, REWORK THE THREE PARTS SHOWN BELOW.
